# **Draft Remedial Investigation Report**

## **Remedial Investigation / Remedial Alternatives Analysis**

### **Martin Aaron Site**

Camden City, Camden County, New Jersey

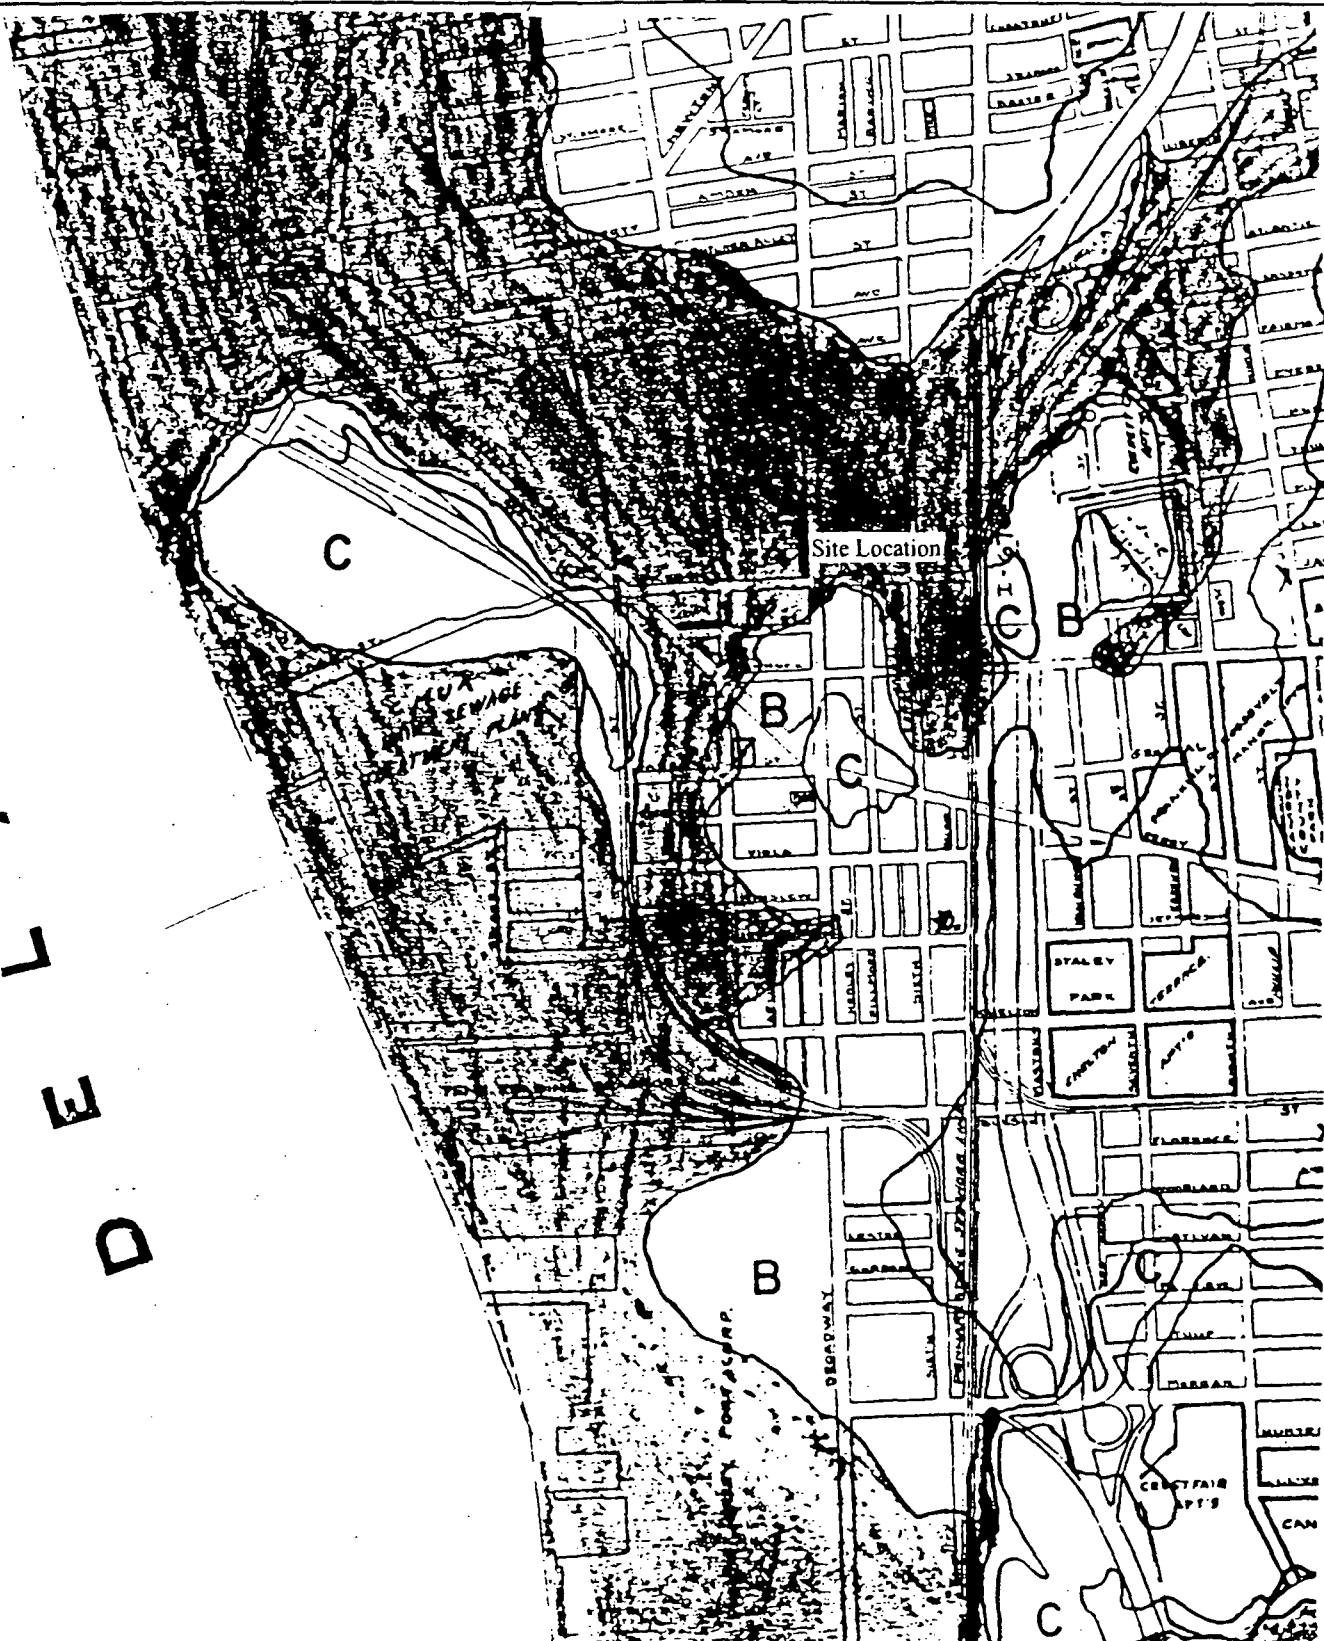
## FIGURE 5

# FLOOD INSURANCE RATE MAP

Source: Federal Emergency Management Agency (FEMA)  
City of Camden; 1989  
Approximate Scale 1" = 400 feet
